U.S. DEPARTMENT OF THE INTERIOR U.S. GEOLOGICAL SURVEY

GEOLOGIC HAZARDS IN THE SUMMIT RIDGE AREA OF THE SANTA CRUZ MOUNTAINS, SANTA CRUZ COUNTY, CALIFORNIA, EVALUATED IN RESPONSE TO THE OCTOBER 17, 1989, LOMA PRIETA EARTHQUAKE: REPORT OF THE TECHNICAL ADVISORY GROUP

Report Prepared for the Federal Emergency Management Agency

U.S. Geological Survey Open-File Report 91-618

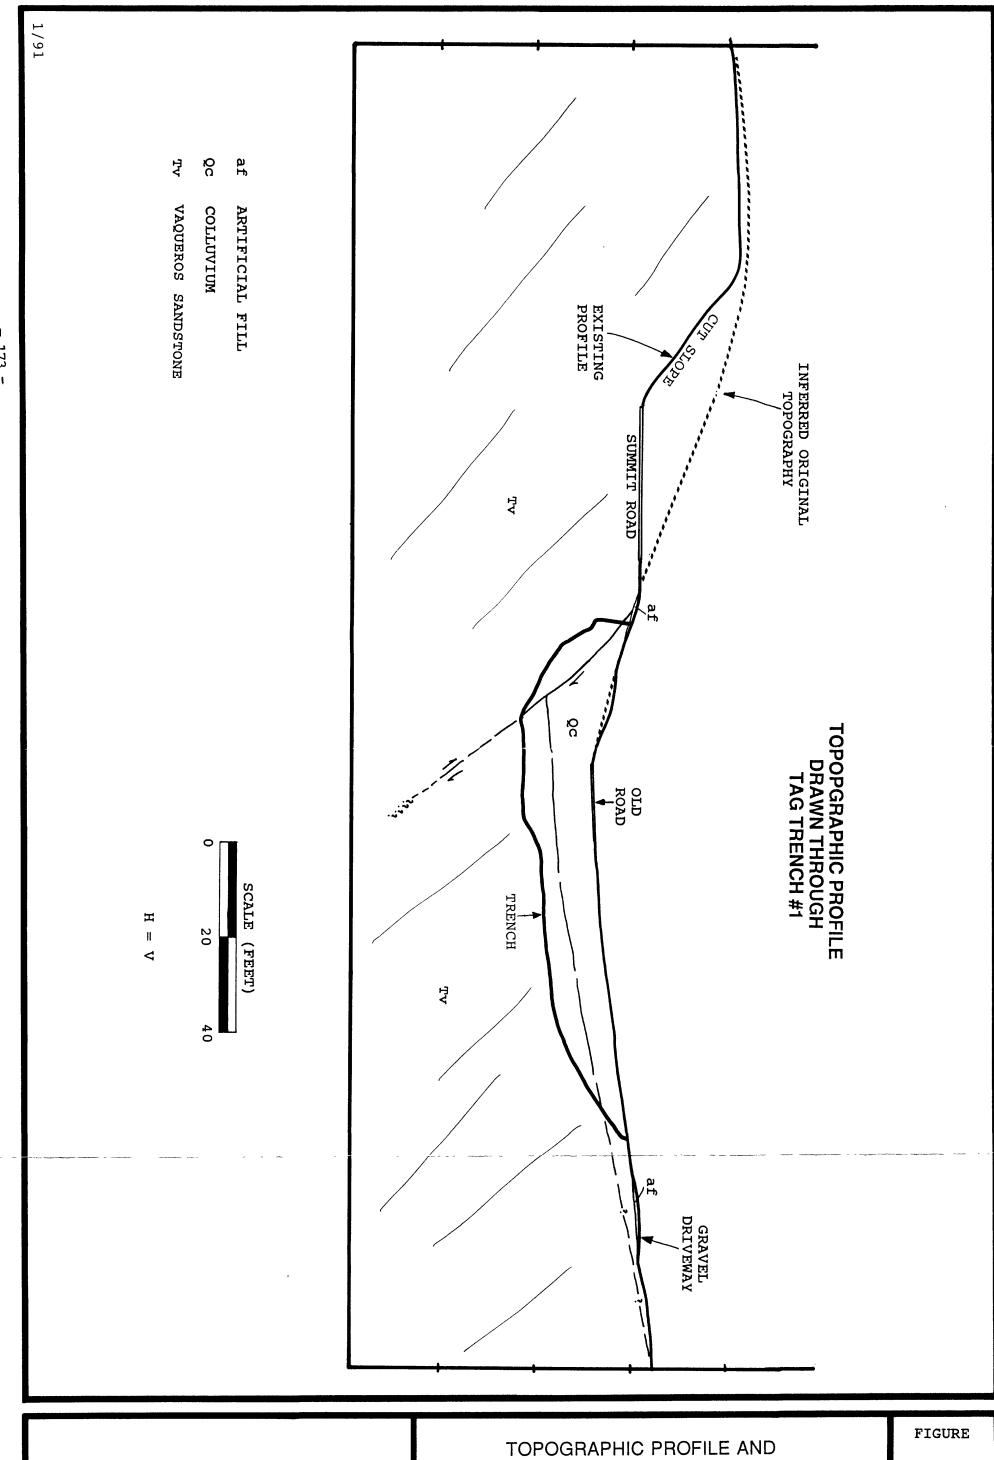
a southwest dipping shear surface. ("Normal" displacement denotes that the block of material above a shear surface moved down relative to the block below.) A sequence of colluvial deposits approximately 12 feet thick overlies the relatively down-dropped block. Figure 5.3 depicts a generalized geologic cross section through the trench.

Normal displacement on the shear surface was evidently accompanied by headward rotation of the down-dropped block, forming a topographic basin at the site (fig. 5.3). No evidence for a matching boundary structure on the southwest side of the basin was observed in the field nor is one required to explain the geometry of existing deposits.

TOPOGRAPHIC PROFILE AND GENERALIZED CROSS SECTION, TAG TRENCH #1

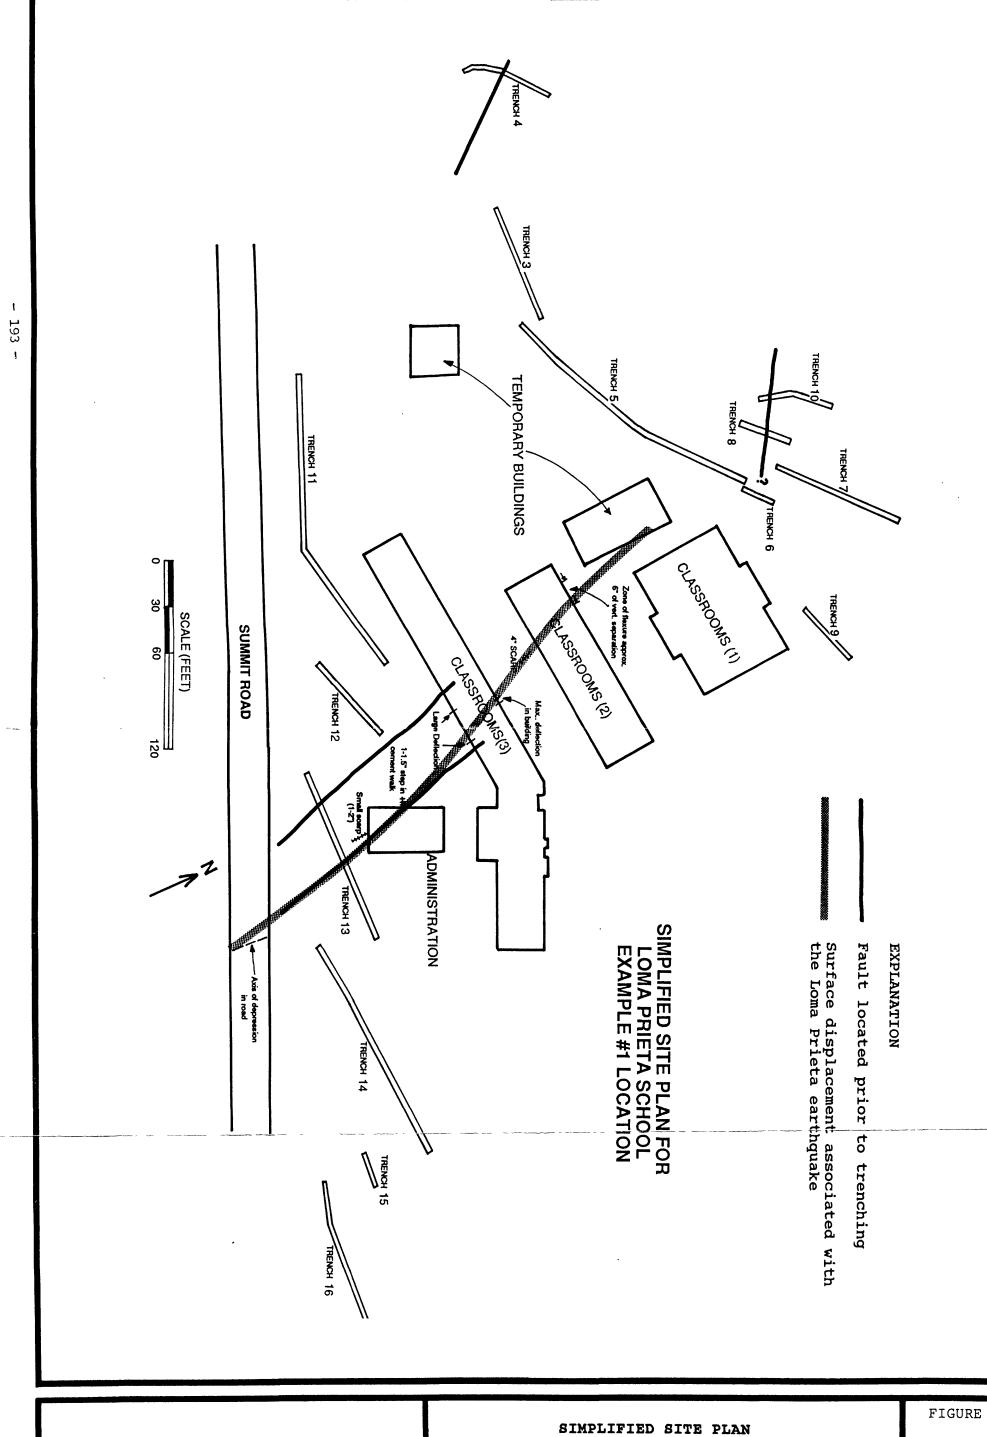
FOR LOMA PRIETA SCHOOL EXAMPLE #1 LOCATION

Displacement of the ground surface during the Loma Prieta earthquake occurred along the trend of the slip surfaces recognized in trench #13. This deformation was not uniform along the projected surface fault trace, but was greatest in the vicinity of classroom building 2 and evidently decreased to the northwest and southeast.

The deformation occurred as flexure of the ground surface, northeast-side down, probably as a result of normal slip at depth. Maximum vertical displacement was approximately 6 inches and occurred across a zone of flexure 10 to 15 feet wide. The examination of earthquake damage took place more than one year after the earthquake, so deformation could only be recorded where preserved by existing structures. Although the trend of the faulting in trenches 8 and 10 (fig. 5.7) is different from that in trench #13, the offset in trenches #8 and 10 lies directly on the projections both of the faults in trench #13 and of the ground-surface deformation resulting from the earthquake. These features are also aligned along the trough that predated the school. For these reasons, the fault orientations in trenches #8 and 10 are considered to be a result of a change in strike of the fault or faults mapped in trench #13. No ground deformation associated with the fault that offsets soil horizons in trench #4 was identified (fig. 5.7).

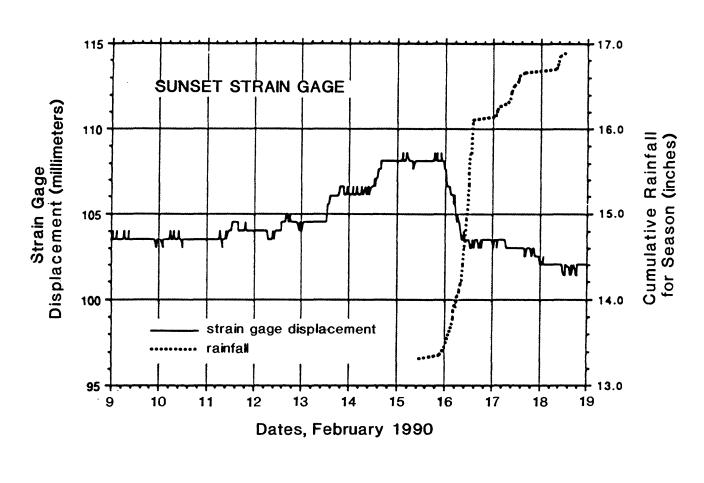
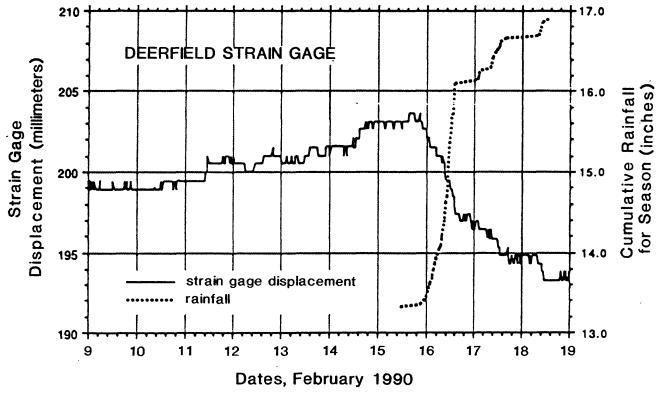
Another more intense storm in mid-February 1990, however, produced 3 to 4 inches of rain in 3 days, and measurements at 18 of the 51 quadrilateral stations following this event showed contractions of 0.8 to 1.6 inches on at least one leg of the quadrilateral. Strain-gage data from the Villa Del Monte landslide complex indicated that the onset of the contraction correlated with the onset of rainfall, with virtually no time lag (fig. 6.3). The direct correlation between rainfall and reduction in cross-crack distance at the quadrilateral sites indicated that the soils at these sites were expanding as they took up water. This pattern was consistently documented at a number of widely-spaced sites during a number of subsequent precipitation events.

FIGURE 6.3 -Rainfall and displacements recorded by two strain gages on Villa Del Monte landslide complex. February 9 through February 18, 1990 (Modified from Griggs and others, 1990).

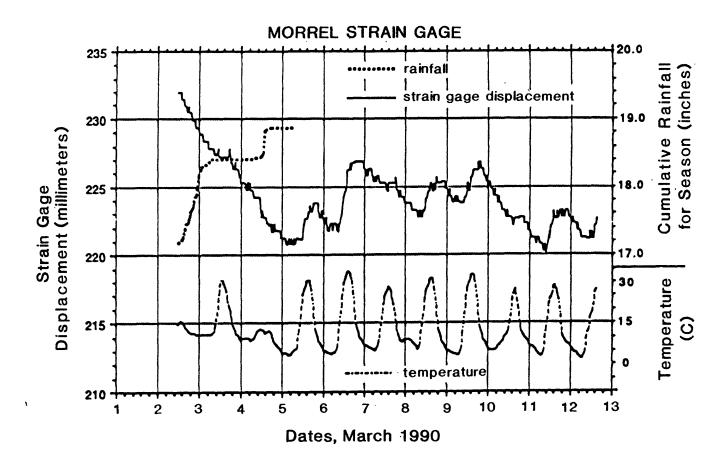
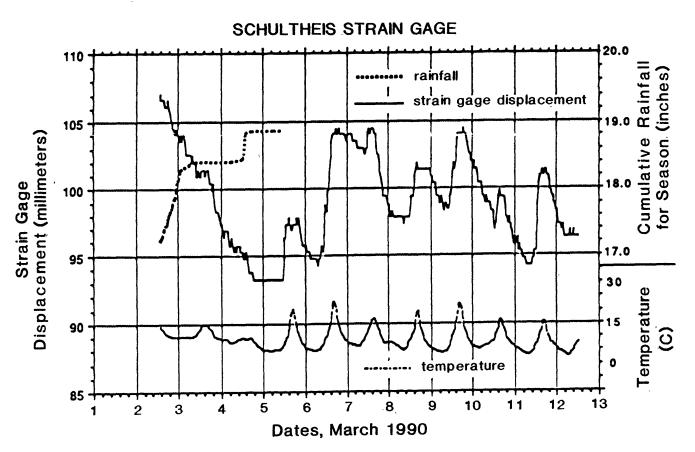
An additional 1 to 2 inches of rain fell in the first 3 days of March, 1990, and this rainfall produced additional contraction across monitored cracks at six of the quadrilateral stations. Strain-gage data again showed a close correlation between onset of precipitation and onset of contraction, and a comparison of the strain-gage data from the Upper Morrell Road and Upper Schultheis Road landslides, which are 1.7 miles apart, showed a nearly identical contraction response to this March rainfall event (fig 6.4). These strain-gage data also showed cycles of expansion and contraction, with amplitudes in the range between 0.08 and 0.20 inches, that evidently correlate with daily temperature fluctuations.

FIGURE 6.4 -Rainfall, temperature, and displacements recorded by two strain gages on Upper Schultheis Road and Upper Morrell Road landslides, March 1 through March 12, 1990 (Modified from Griggs and others, 1990).

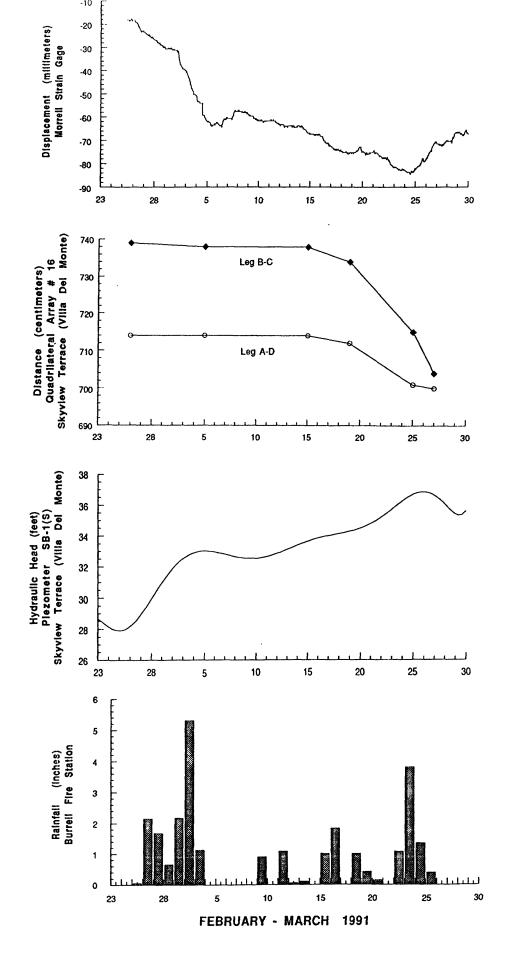
A comparison of rainfall data with both quadrilateral-array and strain-gage records indicated that the observed displacements occurred concurrently with the three most intense rainfall events of the March storm period, which occurred March 2-4, 16-17, and 23-25 (fig. 6.5) The strain-gage record is essentially a mirror image of the piezometric record of ground-water levels shown in figure 6.5, indicating synchronous responses to the March 1991 rainfall. Field observations suggested that the recorded displacements reflected three different general types of movement at the array sites: (1) local expansion or creep of soils induced by increased soil moisture, (2) local sloughing of crack margins, and (3) renewed cracking along scarps related to local readjustment or to headward extension of the monitored landslide masses.

FIGURE 6.5--Comparison of rainfall with example records from strain gage, quadrilateral array, and piezometer; late February-March, 1991, Summit Ridge area.

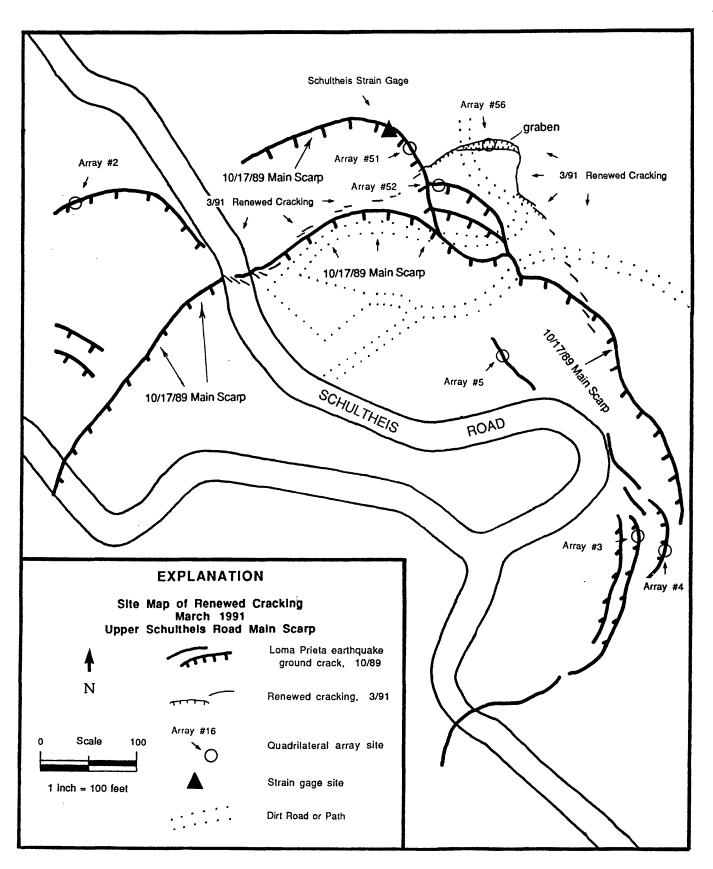
Field observations made on March 25, following additional heavy rains, revealed significant renewed cracking upslope from the main scarp formed during the Loma Prieta earthquake (fig. 6.6). Because these fresh cracks did not occur along the traces of the pre-existing, earthquake-induced cracks, renewed displacement was not detected at nearby quadrilateral arrays #51 or #52 or by the adjacent Schultheis strain gage.

Extending eastward from the main scarp produced by the Loma Prieta earthquake, the fresh crack formed a broad, 100-foot-long arc, concave-downslope, that crossed a dirt access road and entered a small gully. From there, the new crack was traced approximately 50

FIGURE 6.6--Area around main scarp of Upper Schultheis Road landslide showing mapped ground cracks and scarps resulting from the Loma Prieta earthquake; ground cracks, scarps and graben formed during period of heavy rainfall in March, 1991; and locations of quadrilateral arrays and strain gage.

feet downslope, along the gully, to a point where its trend became more easterly; from there, the fresh crack continued eastward, across the slope, for an additional 30 to 50 feet, to a point where it was lost beneath the redwood duff. Between the earthquake-induced main scarp and the access road, the fresh crack feature consisted of a single crack, approximately 50 feet long and 2 to 4 inches wide, showing 2 to 4 inches of vertical displacement. Between the access road and the gully, the cracking consisted of a 50-foot-long, 6- to 10-foot-wide graben, which reached a depth of approximately 20 inches at its center and showed net vertical displacements of 8 to 12 inches between its upslope and downslope margins. The continuation of the cracking from the end of the graben down the axis of the gully was barely discernible; however, the eastward extension of cracking from the gully consisted of several, 4- to 8-inch-wide, en echelon cracks showing as much as 4 inches of vertical displacement.

At several locations upslope from the main scarp of the Upper Schultheis Road landslide, a significant quantity of storm runoff was observed flowing into the newly formed cracks. A new quadrilateral array (#56) was installed on March 27, 1991, across the newly formed graben. Remeasurement of this array 2 weeks later, on April 11, indicated 1.2 inches of downslope extension. Subsequent measurements at this site on April 18, 23, and 30 and May 8 indicated no additional changes in cross-crack distances. field observations made during those visits revealed evidence of minor, partly en echelon, cracking in several locations along the main scarp between the western limit of this renewed cracking and the locality with renewed cracking on Schultheis Road. Similar, partly en echelon cracks were also observed trending downslope from the eastward margin of this renewed cracking, along the eastern portion of the main scarp formed during the Loma Prieta earthquake (fig. A final measurement on July 6, 1991, indicated no additional changes at array #56. The other arrays nearby (arrays #3, 4, 51 and 52 in fig. 6.6) also showed no significant changes between May 8 and July 7, 1991.

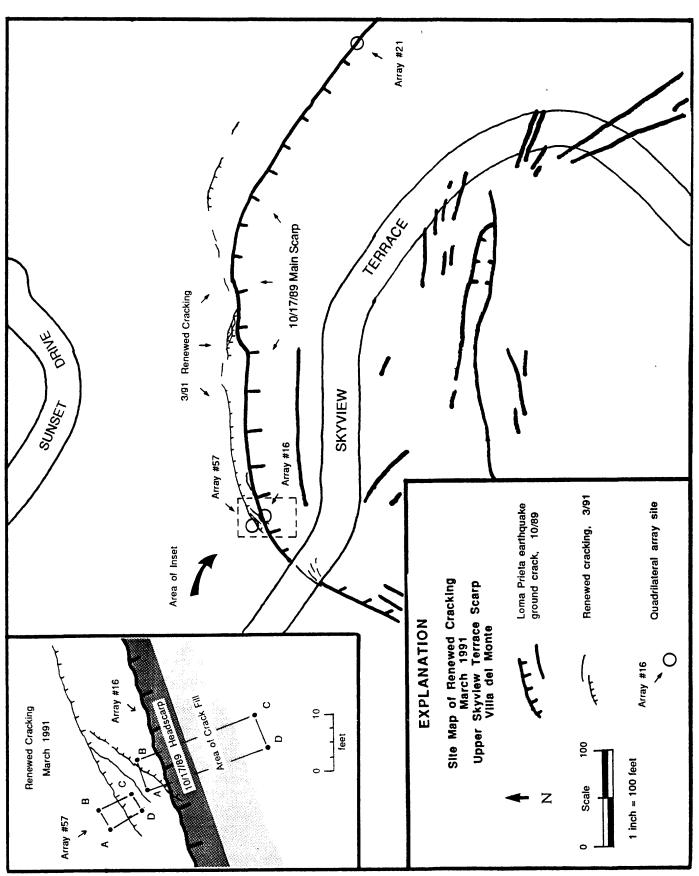
b. Villa Del Monte landslide complex (Upper Skyview Terrace area): The first evidence of renewed cracking and displacement along the major scarp near Upper Skyview Terrace (fig. 6.7) was detected on March 19, 1991. Measurements made at quadrilateral array #16, positioned across this prominent scarp, indicated 0.4 to 0.8 inches of contraction on all four cross-crack quadrilateral legs. An inspection of the area around array #16 revealed that the observed contraction was the result of extension across a newly formed crack, less than 3 feet upslope from the array site and oriented subparallel to the pre-existing scarp (fig. 6.7) 0.8- to 2.0-inch-wide crack, which formed sometime between March 15 and 19, showed no vertical displacement. The crack was traceable at least 30 feet eastward from the array site, until lost beneath the thick brush upslope from the scarp. Minor (less than 0.4 inches wide) en echelon cracking was also observed in the pavement of upper Skyview Terrace, where that road crossed the scarp near array site #16.

Measurements made at array #16 on March 25, following additional heavy rain, revealed additional cross-crack contractions of 4.3 to 7.5 inches. The new crack noted on March 19 appeared unchanged; however, a significantly larger crack, approximately 3 feet farther upslope, had formed between March 19 and 25. This new crack, 2 to 6 inches wide and showing 2 to 6 inches of downslope vertical displacement, was oriented subparallel to the pre-existing scarp and could be traced continuously approximately 130 feet eastward through thick brush to a dirt access trail. From that point, the crack was traceable for another 250 feet eastward, but showed only discontinuous expression as a 2- to 6-inch-wide crack with vertical displacements of as much as 6 inches. Although this crack was not traceable very far west of array #16, the previously minor cracking in the road had increased noticeably.

On March 27, additional renewed cracking was observed above the scarp, and another, discontinuous crack had developed downslope from the new cracks. This newest crack, which was an average of 2 inches wide and showed as much as 2 inches of vertical displacement, was traceable for 13 feet, trending obliquely uphill from the edge of the original scarp and passing between stakes A and B of quadrilateral array #16 (inset in fig. 6.7). Quadrilateral measurements revealed 4.3 inches of contraction on the two cross-

FIGURE 6.7--Upper Skyview Terrace area of Villa Del Monte, showing mapped ground cracks and scarps resulting from the Loma Prieta earthquake; ground cracks and scarps formed during period of heavy rainfall in March, 1991; and locations of quadrilateral arrays.

crack legs involving stake B (i.e., legs BC and BD) and no significant change on the two legs involving stake A (i.e., legs AC and AD). During the March 27 visit to this site, a new quadrilateral array (#57) was installed across the extensive new crack first observed on March 25 (inset in fig. 6.7). Subsequent measurements made at both arrays #16 and #57 on April 11, 18, and 23 and May 8 indicated no additional movement at this locality. A final visit on July 6 revealed that stake D had been removed from array #16, but measurements from the remaining stakes indicated no change from the May 8 readings. All but one of the measurements at the new array, #57, on July 6, were within 0.8 inches of the May 8 readings.

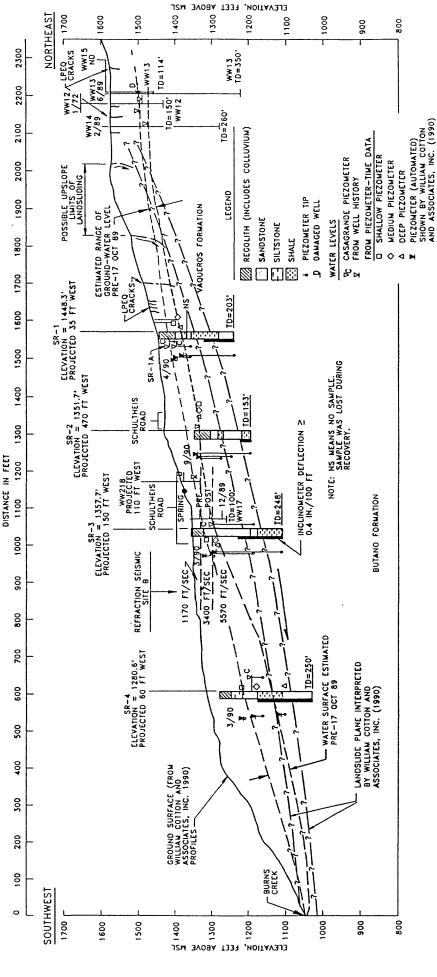
URE 8.1 - Estimated Upper and Lower Locations of Basal Shear Surfaces for Section SR, Upper Schultheis Road Landslide, from (1990)Inc. William Cotton and Associates, FIGURE 8.1

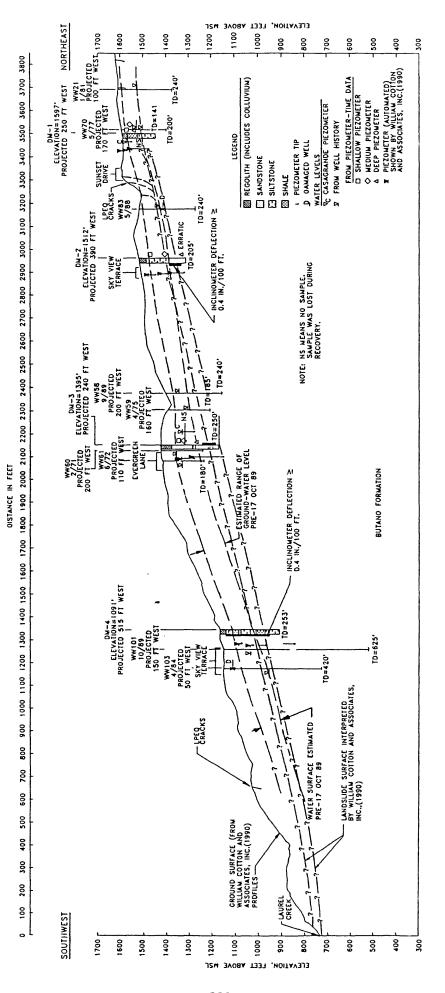
Surfaces for Section DM, Villa Del Monte Landslide Complex, from FIGURE 8.2 - Estimated Upper and Lower Locations of Basal Shear William Cotton and Associates, Inc. (1990)

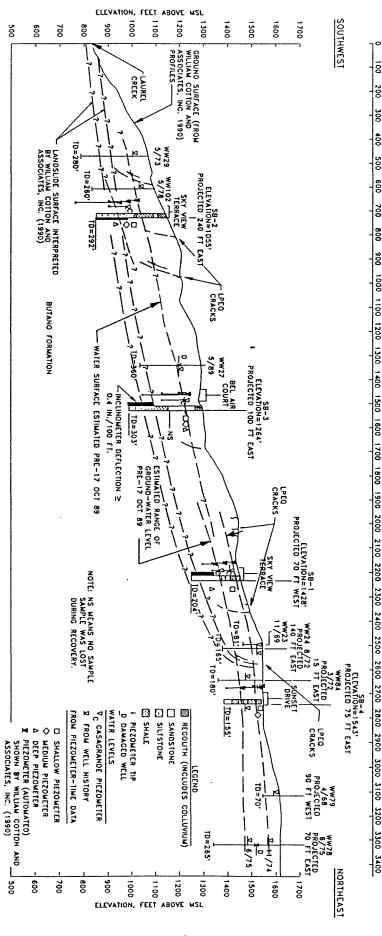
FIGURE 8.3 Surfaces for Section SB, Villa Del Monte Landslide Complex, from William Cotton and Associates, Estimated Upper and Lower Locations of Basal Shear Inc. (1990)

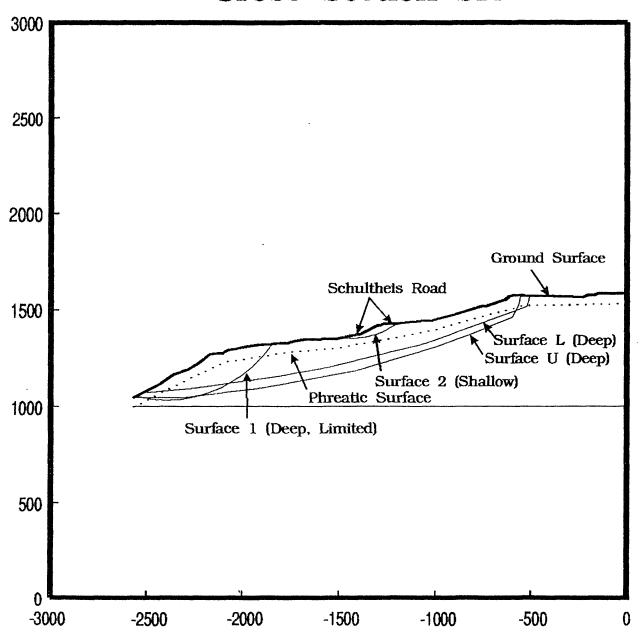
FIGURE 8.4 - Assumed Locations of Shallow and Deep Sliding Surfaces for Section SR, Upper Schultheis Road Landslide

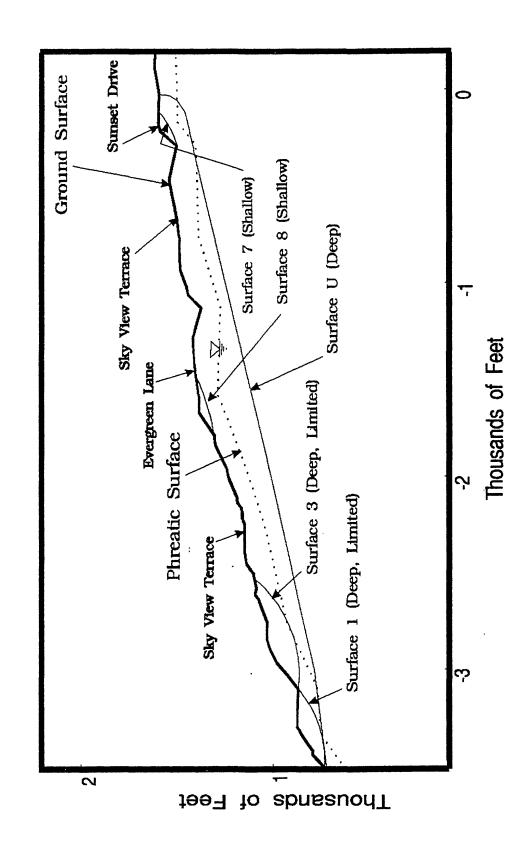
FIGURE 8.5 - Assumed Locations of Shallow and Deep Sliding Surfaces for Section DM, Villa Del Monte Landslide Complex

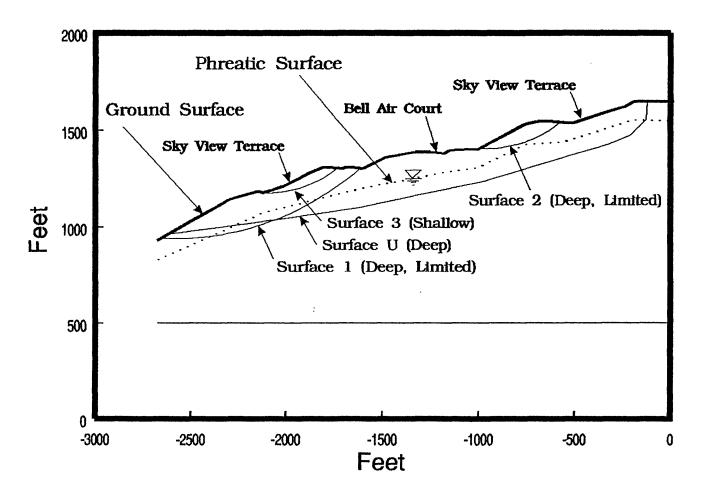
FIGURE 8.6 - Assumed Locations of Shallow and Deep Sliding Surfaces for Section SB, Villa Del Monte Landslide Complex

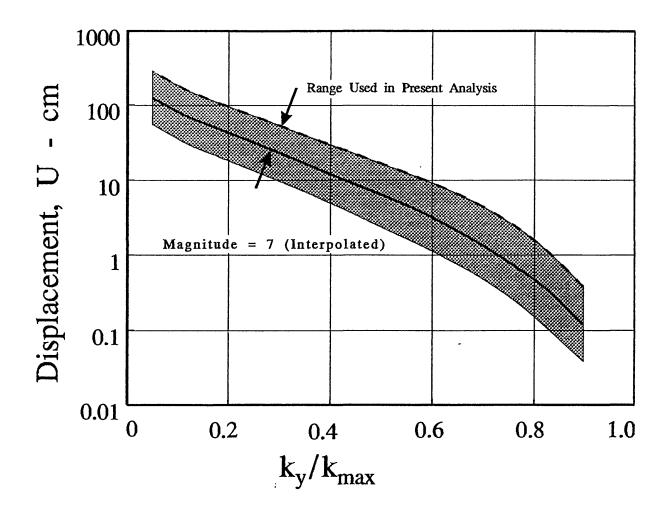
FIGURE 8.17 - Average and Range for Relation Between Accumulated Newmark-Sliding-Block Displacement, U, and Acceleration Ratio, k_y/k_{max} , for Interpolated Magnitude 7 Earthquakes after Makdisi and Seed (1979)
